- Evaluation of Aircraft Armament Installation
 (F-86F with 206 RK Guns)
 Project Gun-Val (Title Unclassified)
- February 1955

AIR FORCE ARMAMENT CENTER
Air Research and Development Command
EGLIN AIR FORCE BASE, FLORIDA

Evaluation of Aircraft-Armament Installation (F-86F with 206 RK Guns)

Project Gun-Val

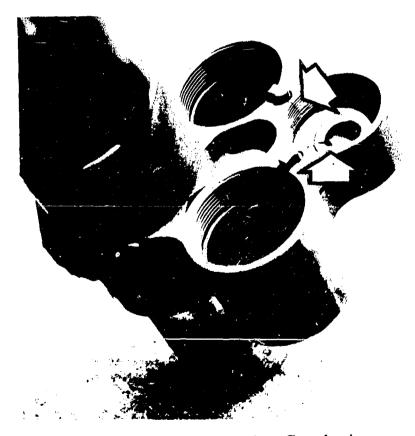
Metal fatigue, resulting from gun vibration, caused the gas cylinder brackets to crack (Fig. 14). This type of failure occurred in each of three guns after firing 1286, 1133, and 1321 rounds.

Fig. 14: View Showing Cracks in the Gas Cylinder Bracket After Firing 1286 Rounds

The results of this test indicate that the engineering principles employed in the design of the 206 RK gun are sound. Gun performance can be improved by strengthening the gas cylinder bracket, slide, extractor, drive springs, drum roller springs, and charging cylinders and redesigning the second stage round retainer.
